Dental Imaging Diagnostics LLC

Patient Name: Lastname, Firstname
Referring Doctor: Dr. Sample – Sample Dental
Study: CBCT

Impression:

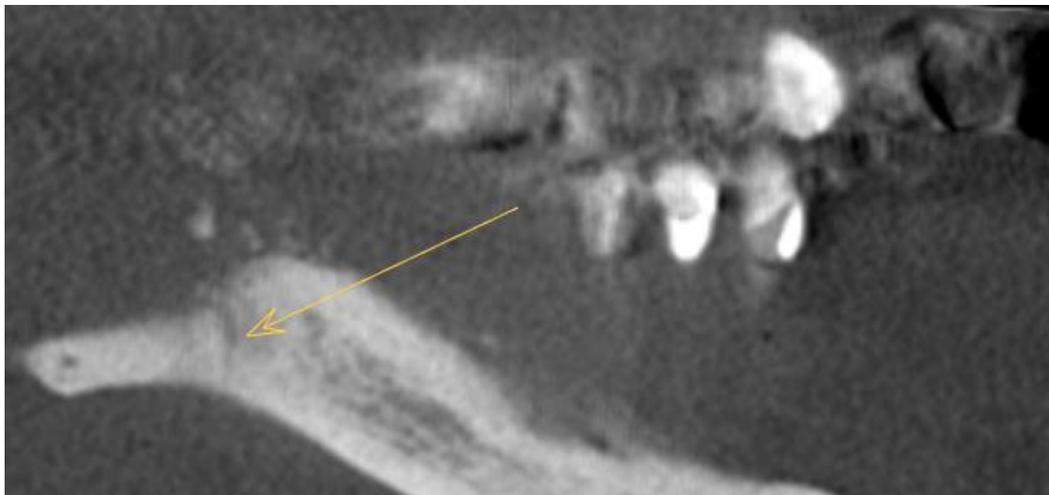
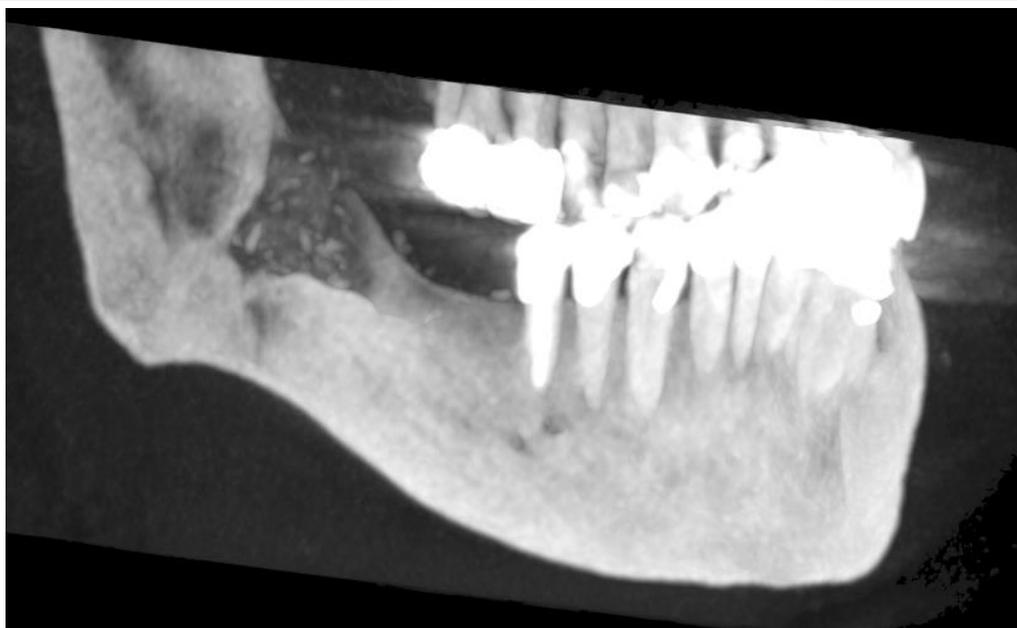
- Evidence of non-displaced pathologic fracture along the thinned buccal cortical plate at the site of E+C of histopathologically proven dentigerous cyst near the right antegonial notch.

- Evidence of a thin fracture line along the buccal cortex in the region of the antegonial notch as seen on prior panoramic imaging. No evidence of displacement or step defect.

Arch view in the plane of the buccal cortical plate (top) and MIP volume render (bottom) of suspected pathologic fracture near right antegonial notch.
